# Catch My drift

Consultation on the restoration options for East Chevington Nature Reserve

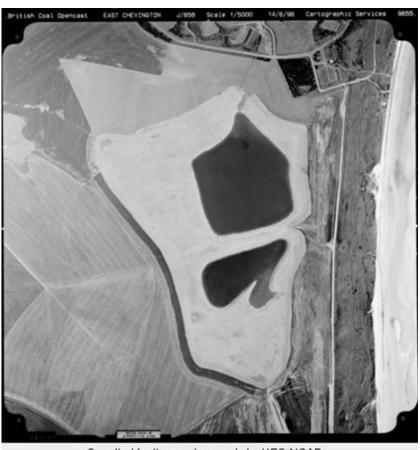
Historic imagery (1996)

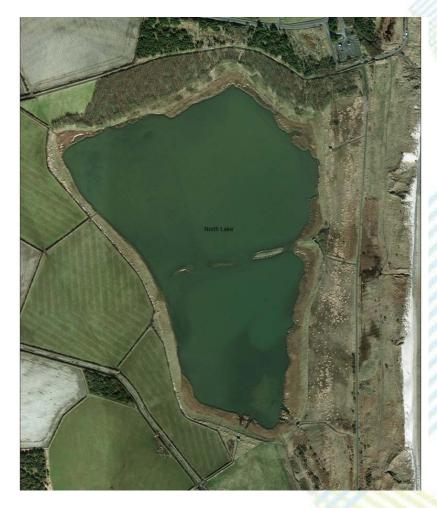
Current imagery

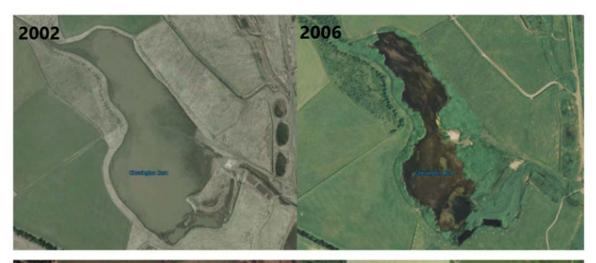
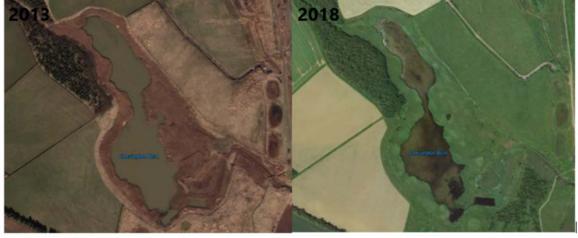
Outflow from lake

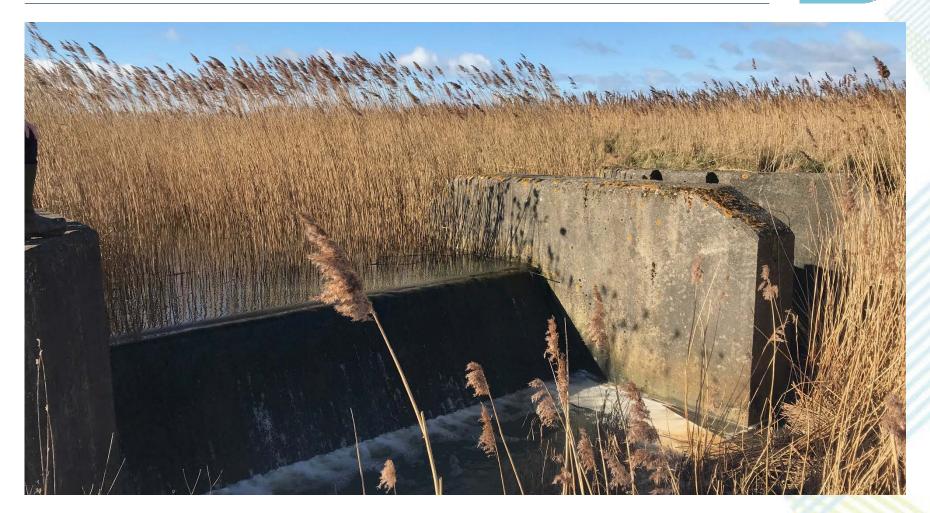
## South Lake (Chevington Burn)

**Control Structure**

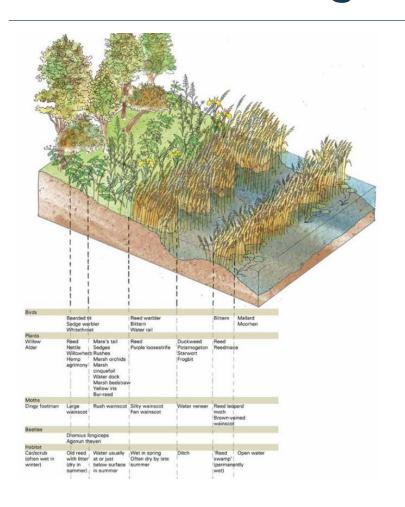
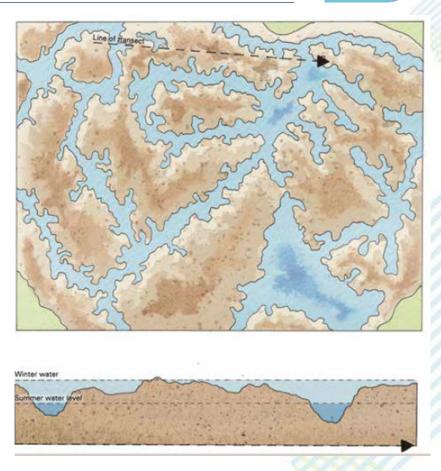
Diverse reedbed edge

Matrix of pools and reedbeds

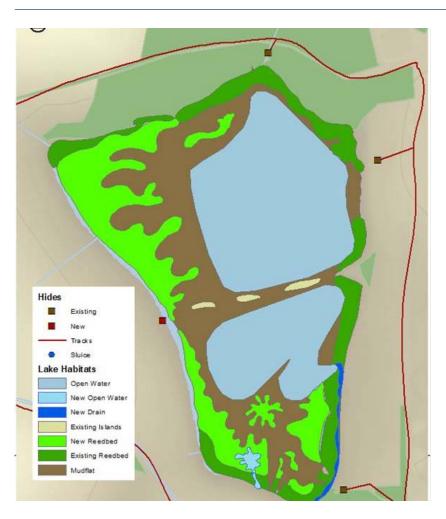
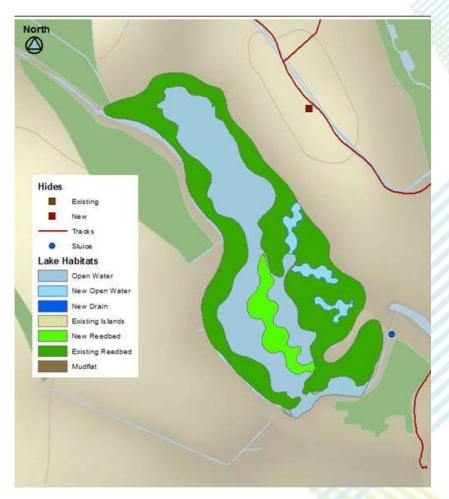
North Lake

South Lake

- Retrofitting control structures with functional gates
- Reinstatement of drainage ditch within northern lake
- Reprofiling lake beds to create more diverse habitat
